INDOOR AIR QUALITY ASSESSMENT

Northwest Elementary School 45 Stearns Avenue Leominster, MA 01453

Prepared by:
Massachusetts Department of Public Health
Center for Environmental Health
Emergency Response Indoor Air Quality Program
September 2005

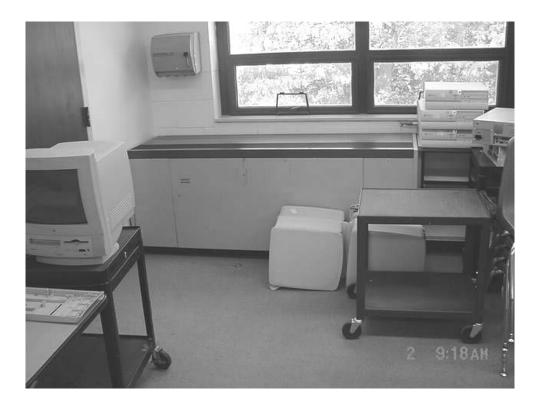
Fresh air in exterior classrooms is supplied by unit ventilator (univent) systems equipped with high efficiency pleated filters (Pictures 1 and 2). A univent is designed to draw air from outdoors through a fresh air intake located on the exterior wall of the building (Picture 3). Return air is drawn through an air intake located at the base of the unit (Figure 1). Fresh and return air are mixed, filtered, heated and provided to classrooms through an air diffuser located in the top of the unit. All univents were operating during the assessment, with the exception of the cafeteria. Obstructions to airflow, such as papers and books stored on univents and

Classroom Univent

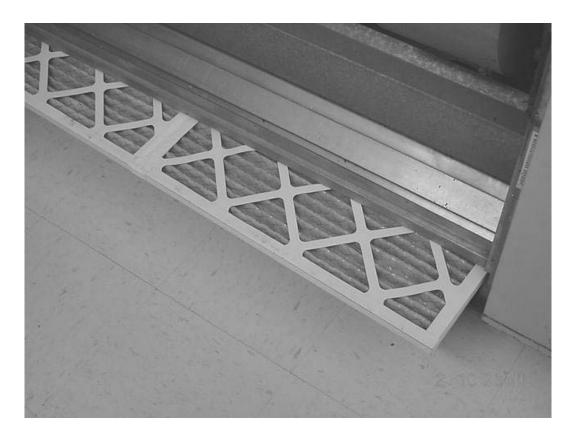
High-Efficiency Pleated Air Filters in Univent

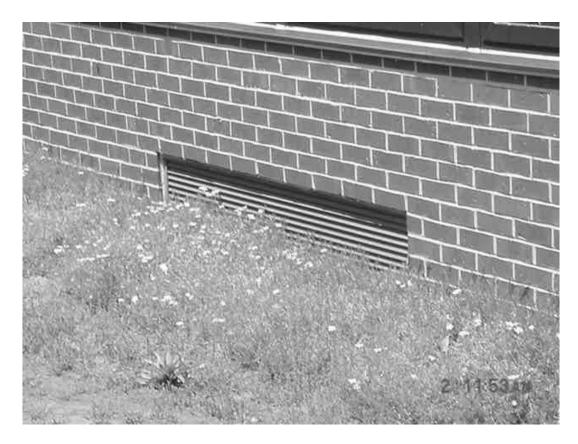
Plants were noted in several classrooms, and flowering plants were seen in close proximity to univent air intakes (Picture 3). Plants can be a source of pollen and mold, which can be respiratory irritants for some individuals. Plants should be properly maintained and equipped with drip pans. Plants should also be located away from ventilation sources (e.g., air intakes, univent diffusers) to prevent the entrainment and/or aerosolization of dirt, pollen or mold.

Univent Air Intake, Note Flowers in Front of Intake

- 7. Ensure plants have drip pans. Examine drip pans periodically for mold growth and disinfect with an appropriate antimicrobial where necessary. Keep plants away from the air stream of univents.

- 8. Clear plant growth away from the proximity of univent air intakes.
- 9. Clean and maintain aquariums and terrariums to prevent mold growth and associated odors.

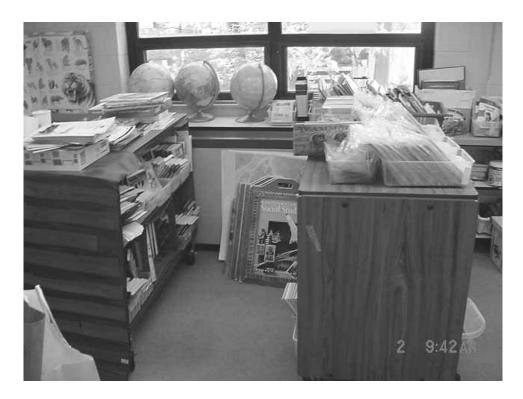
bookcases, carts and desks in front of univent returns, were seen in several classrooms (Picture 4). In order for univents to provide fresh air as designed, units must be activated and remain free of obstructions.

Univent Obstructed by Various Items

- 3. Remove all blockages from univents and exhaust vents to ensure adequate airflow.
- 4. Close classroom doors to maximize air exchange.
- 5. For buildings in New England, periods of low relative humidity during the winter are often unavoidable. Therefore, scrupulous cleaning practices should be adopted to minimize common indoor air contaminants whose irritant effects can be enhanced when the relative humidity is low. To control for dusts, a high efficiency particulate arrestance (HEPA) filter equipped vacuum cleaner in conjunction with wet wiping of all surfaces is recommended. Drinking water during the day can help ease some symptoms associated with a dry environment (e.g., throat and sinus irritations).

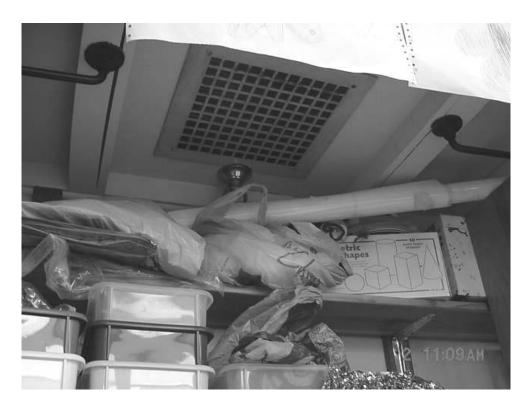
Mechanical exhaust ventilation for classrooms in the 1955 portion of the building is provided by vents located in the ceilings of coat closets (Picture 5). Air is drawn into the coat closet through the undercut below closet doors and exhausted out of the building through a centralized tower (Pictures 6 and 7). The design/location of exhaust vents allows for easy blockage by stored materials. The majority of these exhaust vents were operating, however no draw of air was detected in classrooms B1, B9 and A5, which can indicate that motors were deactivated or non-functional. As with the univents, in order to function properly, exhaust vents must be activated and remain free of obstructions.

Exhaust Vent for 1955 Wing, Note Storage of Materials below Vent

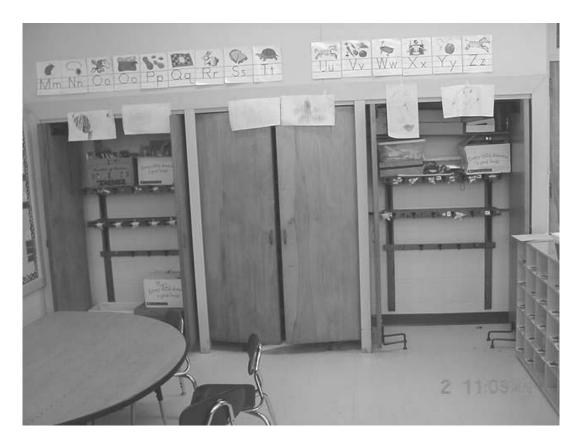
Undercut Coat Closet Doors for Exhaust Ventilation

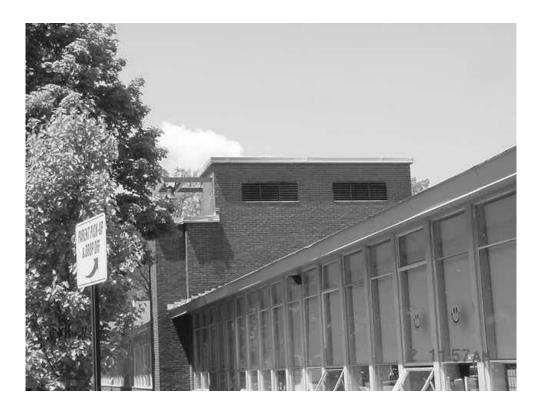
Exhaust Tower

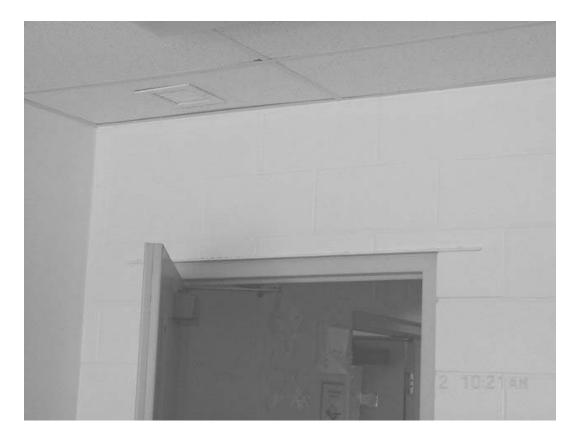
Exhaust ventilation in the 1960s portion of the building is provided by ceiling-mounted vents powered by rooftop motors (Pictures 8 and 9). These exhausts were all operating during the assessment. However, the location of some exhaust vents can limit exhaust efficiency. In several rooms, exhaust vents are located near hallway doors (Picture 8). With hallway doors open, exhaust vents in these rooms will tend to draw air from both the hallway and the classroom reducing the effectiveness of the exhaust vent to remove common environmental pollutants.

Ceiling-Mounted Exhaust Vent (1960's Wing), Note Open Hallway Door

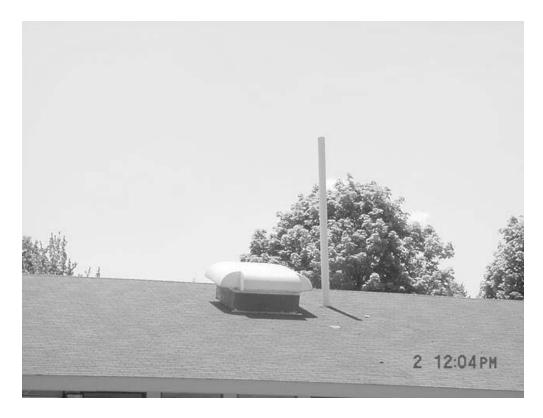
Rooftop Exhaust Motor

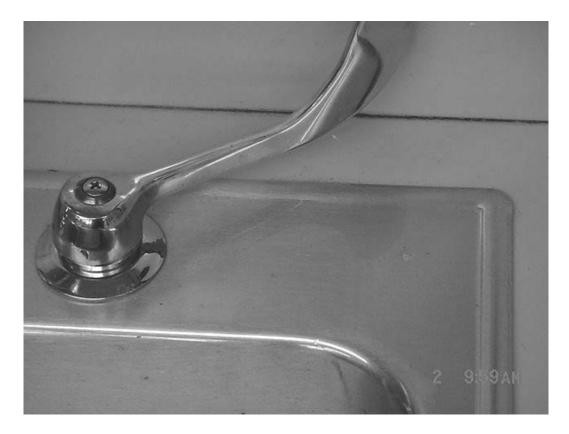
Space between Sink Backsplash and Countertop

- 10. Seal areas around sinks to prevent water-damage to the interior of cabinets and adjacent wallboard.
- 11. Continue with plans to remove and replace carpeting with a non-porous materiel (e.g., tile).

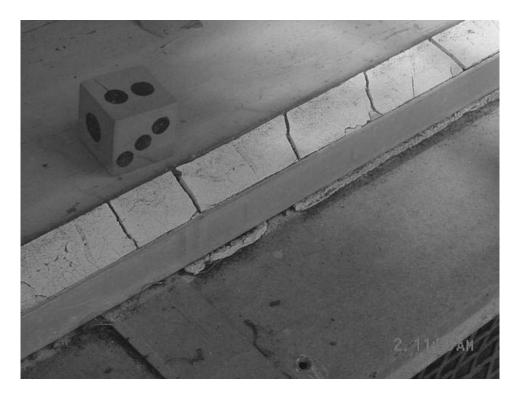
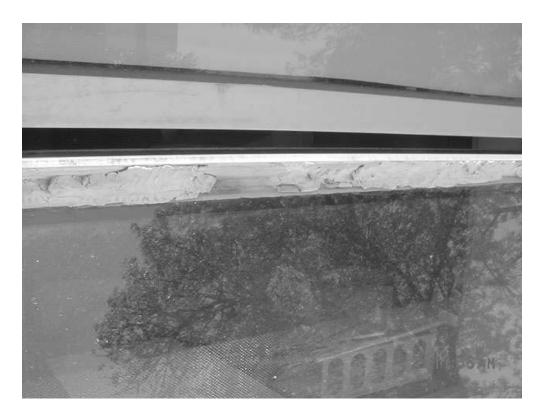
Caulking around window panes along the west side of the building was observed to be missing/failing in several areas (Pictures 11 and 12), which can lead to water penetration and potential water damage and/or mold growth. As discussed, window replacement for this portion of the building is on a capital repair list.

Missing/Damaged Caulking along West Side Windows
